**Topic 3**  
**“Safety in field and in greenhouses”**

## **A New European Standard for cab Filters Performance Evaluation: Content and Criticism**

Balsari P.<sup>1</sup>, Ghigo D.<sup>1</sup>

<sup>1</sup>*University of Torino. DEIAFA, Mechanics Section*

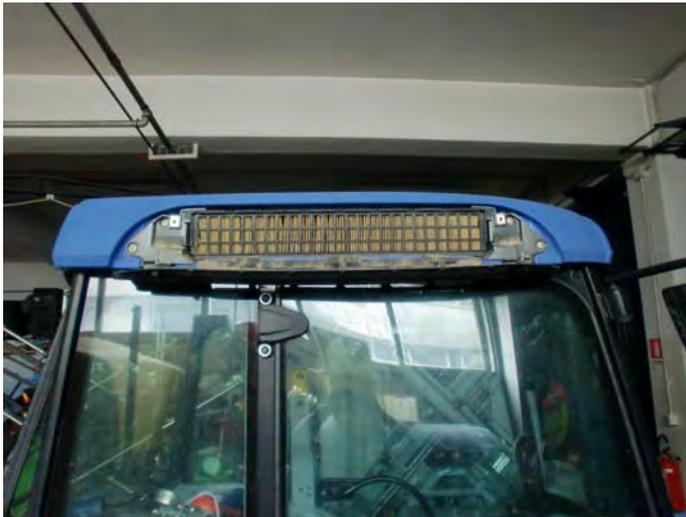
*Figure 4\_ Particular of cabin filter housing*

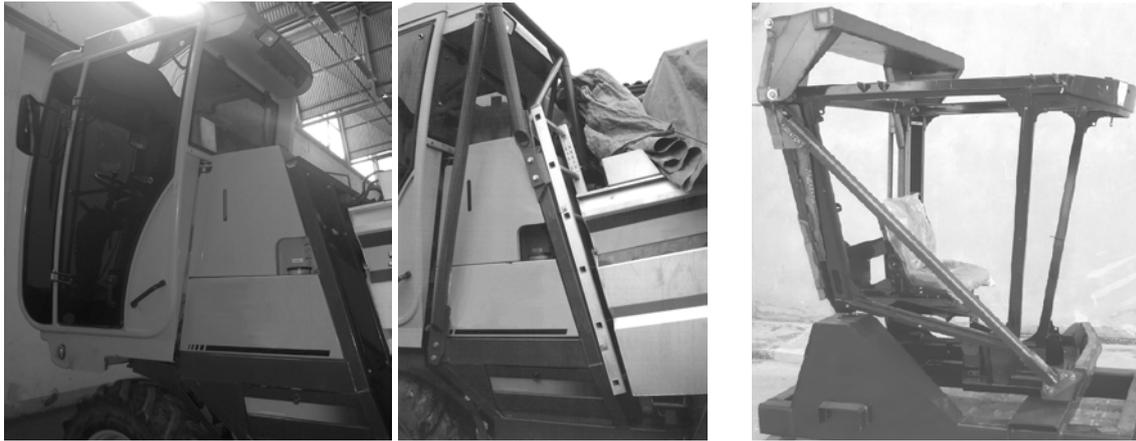
**Figure 1. Tested ROPSs. (a) CASE 1 (b) CASE 2**

Strength tests on two ROPS protective structures (CASES 1 and 2), fitted on two different in-use grape harvesters, were carried out at the laboratory of the Department of Agricultural Economics and Engineering (DEIAgra) of the University of Bologna, according to the provisions of the OECD Codes 4 and 8. Originally the two machines were marketed with cabs aimed at protecting the driver from environmental conditions. The manufacturers, so as to prevent injury to the driver during a rollover, designed dual pillar ROPS retrofitted behind the cab originally mounted (Figure 1).

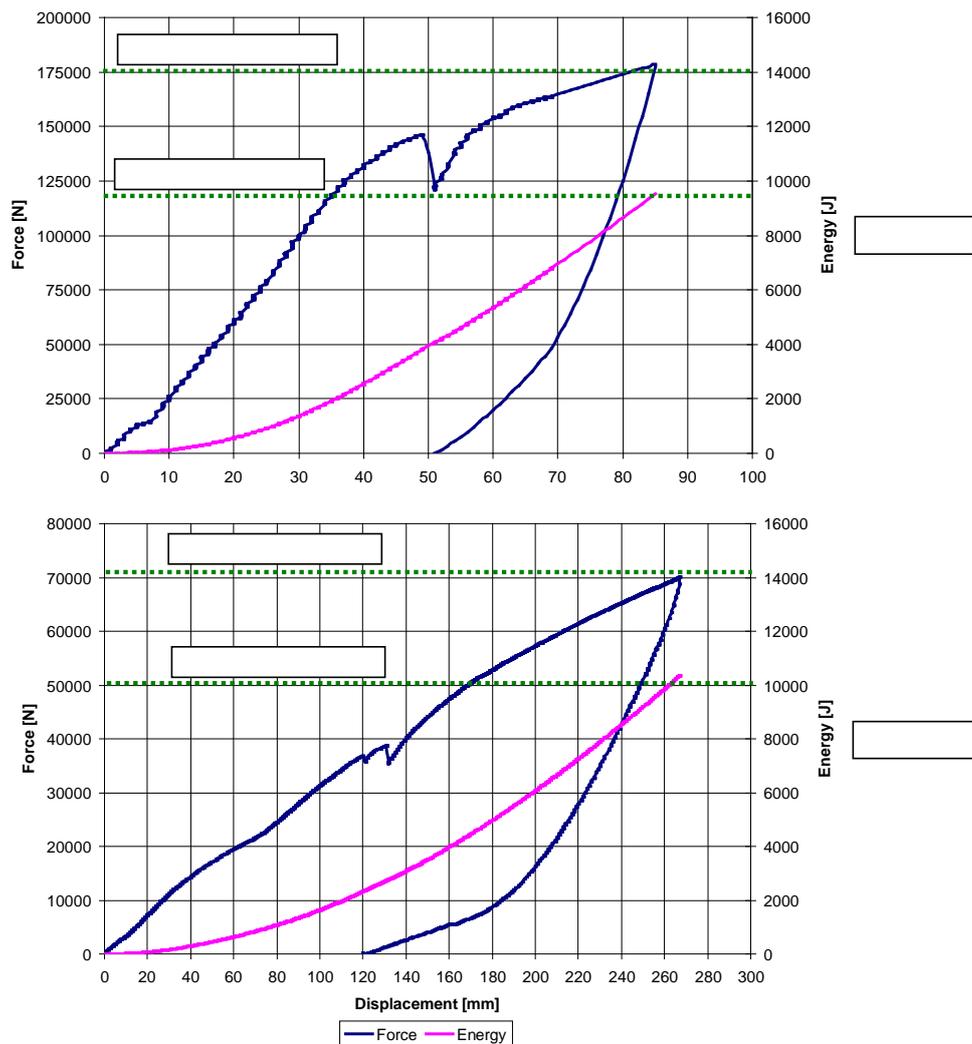
**Figure 3. Force and Energy measured during the side loading tests**

Tests were carried out without breakages and the safety volume was not infringed.

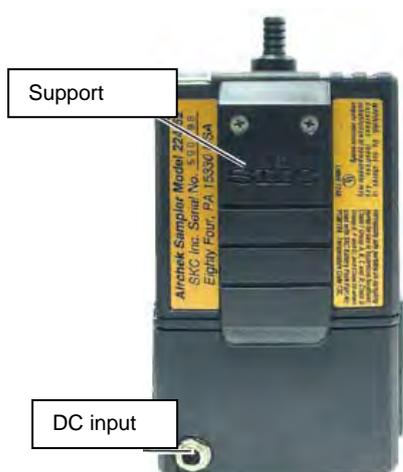
Figure 1. SKC Pump™

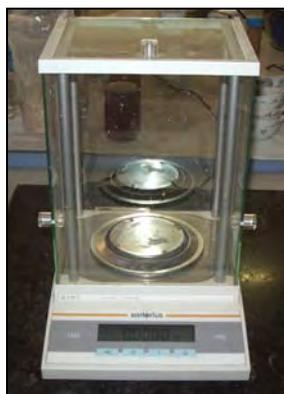
Figure 4. Analytical balance Sartorius

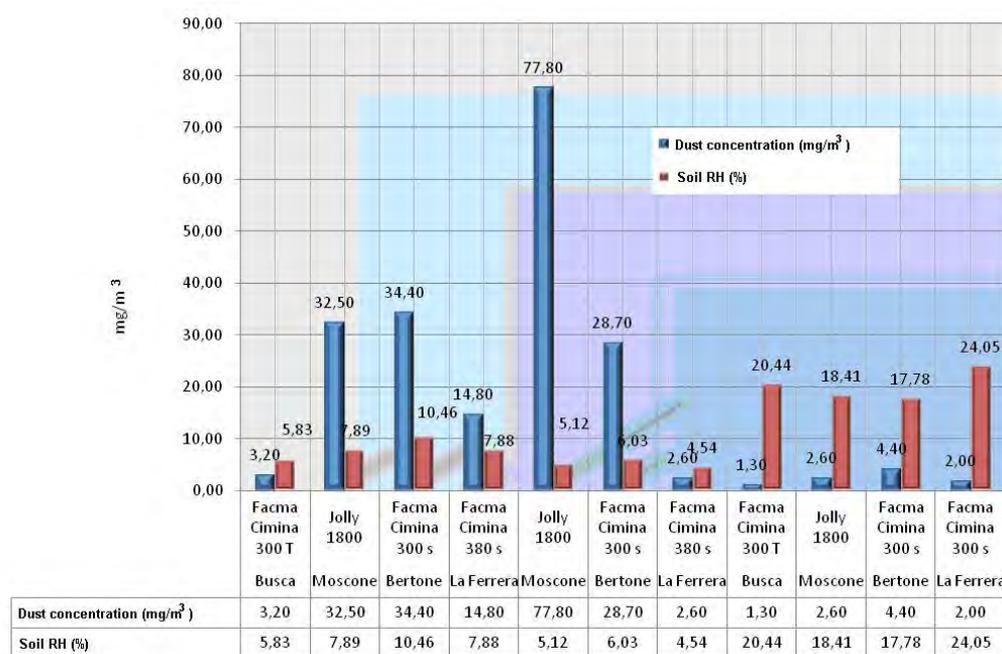
**Figure 5. Dust concentration during hazelnut harvesting**

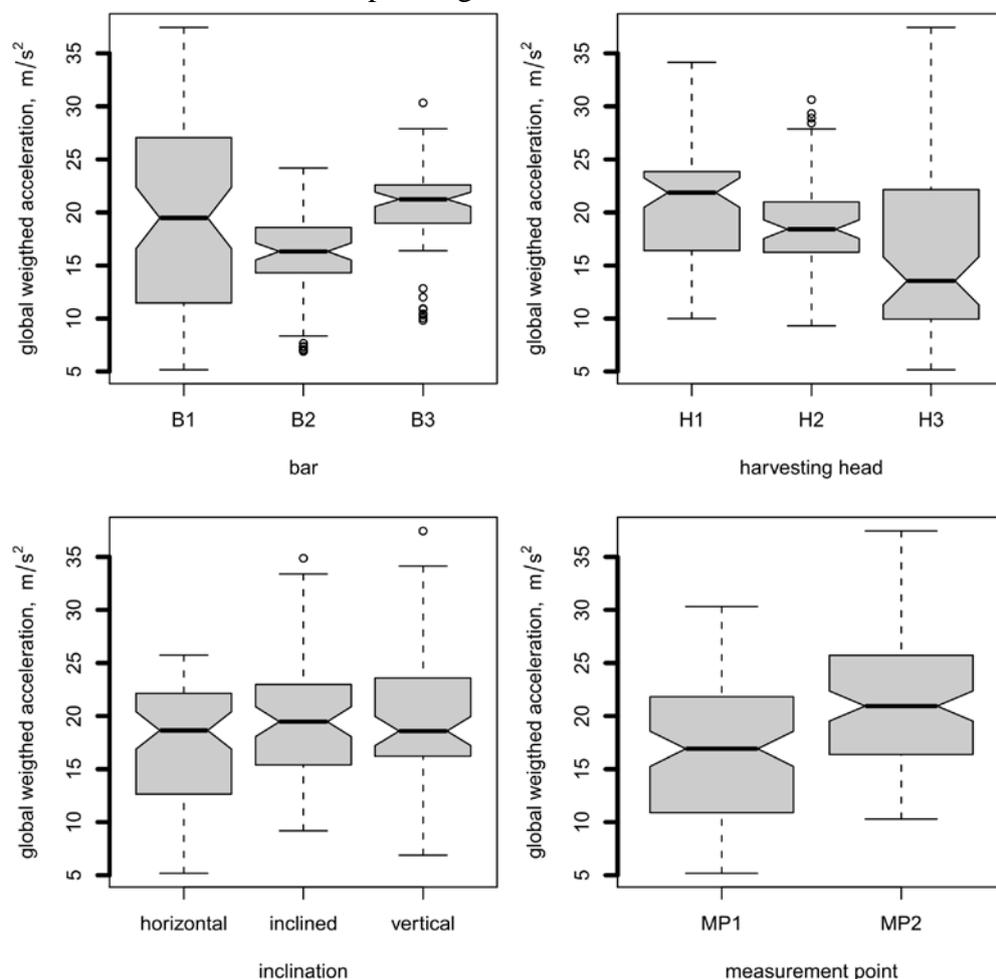
**Figure 5. Global weighted accelerations.**

misaligned, the lowest by H3, which oscillates around the axis to which the operating tools are connected. This confirm that the vibration level can be reduced mainly acting on the mechanism that moves the operating tools.

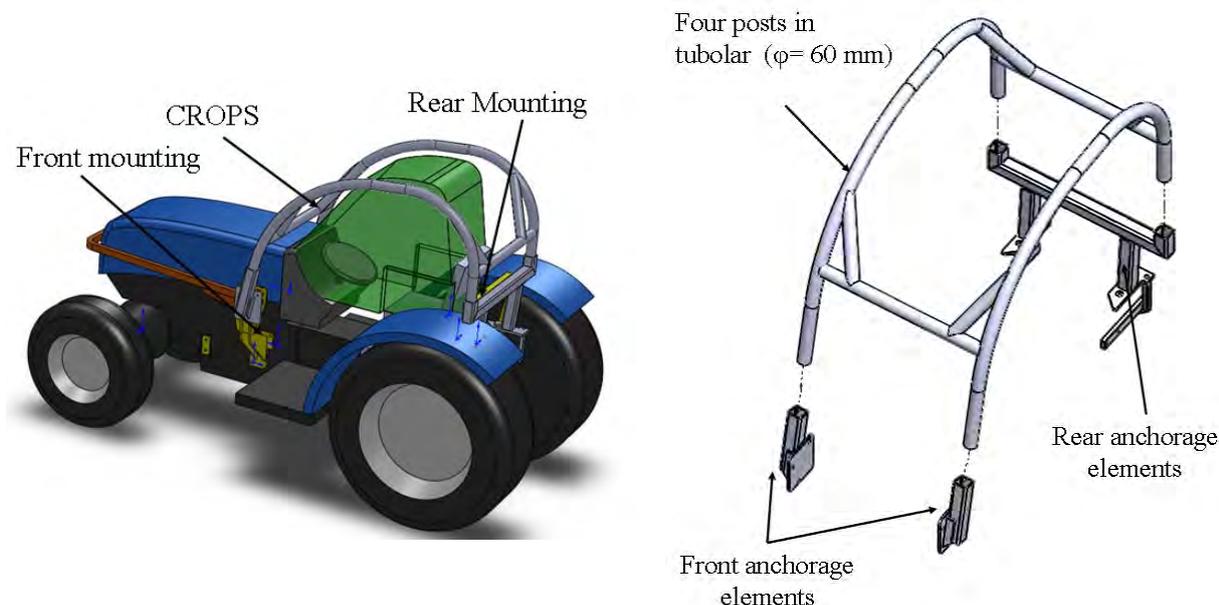
Figure 6. The first virtual prototype of the CROPS.

In any case the main function of CROPS is to protect the operator clearance zone. Thus, its size, with respect to this first prototype, has been varied according to the results of structural simulations which leads to the optimization process.

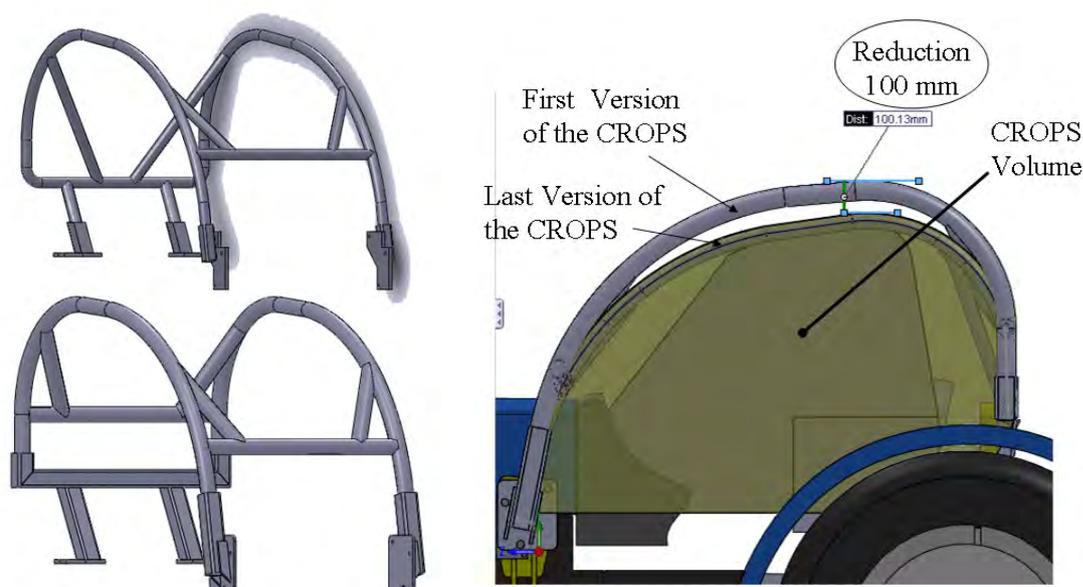
**Figure 9. Comparison between first and last CROPS versions**

Each of the cited aspects led to new version of CROPS for which it is necessary a new design and finite element analysis, as previously described. So, the CROPS final version is the best compromise between structural and practical requirements, even if it probably could be still enhanced. The left hand side of figure 9 compares the first, on the bottom, and the last, on the top, versions of CROPS, where a steel tubular with a reduced cross section has been used. The right hand side of figure 9 shows that one of the effects of the optimization was the reduction of other 100 mm to the overall height of the tractor, continuing to ensure operator protection.

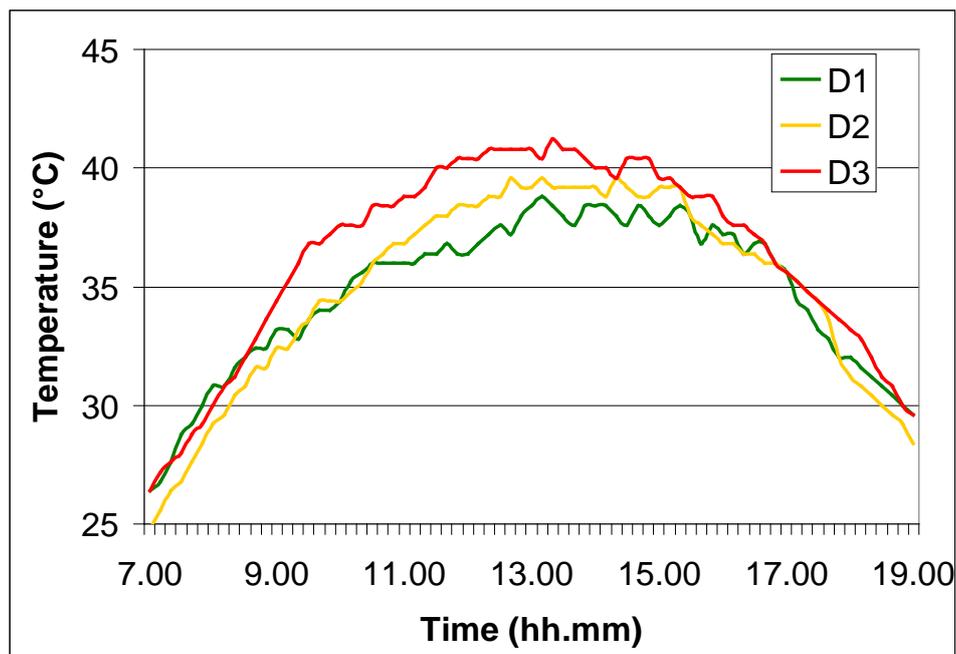
## Figure 2. Indoor thermal evolution during D1 D2 and D3

Based on such data, three days with outdoor high temperatures of 28°C, 31°C and 34°C have been selected for this study. Such days, hereafter indicated with D1 D2 and D3, have been identified as a typical warm, hot and exceptionally hot summer day respectively, and the daily evolution of indoor temperature during each of those days is presented in Figure 2.

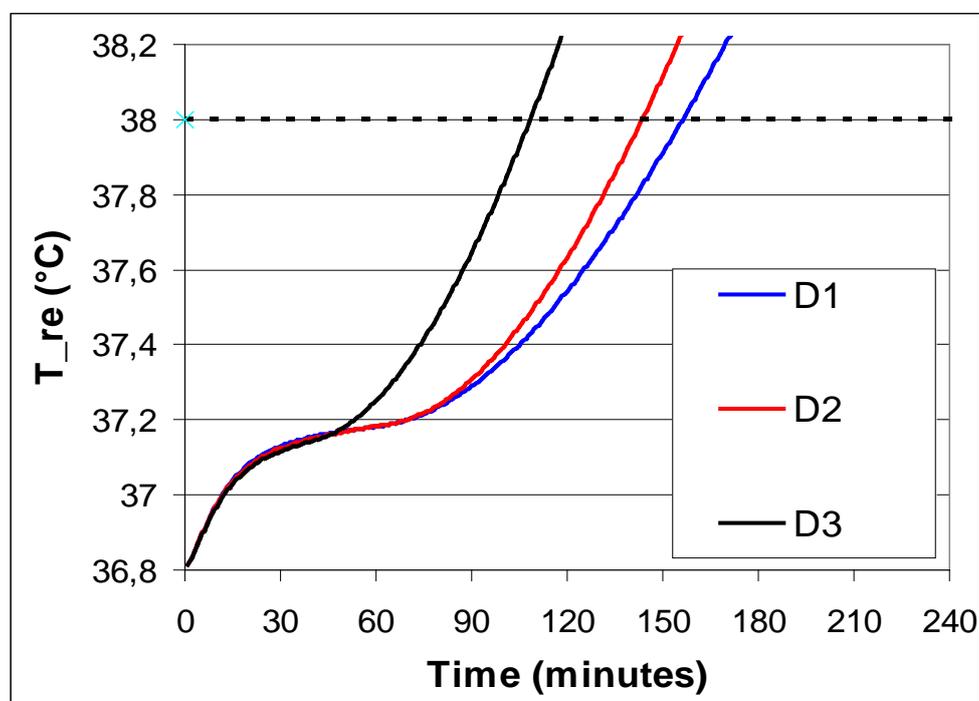
Figure 3. Rectal temperature evolution during days D1 D2 and D3

Figure 3 shows the rectal temperature evolution during D1 D2 and D3, where work has been assumed to start (Time = 0) at 7 am. The horizontal dashed line represents the maximum tolerable rectal temperature  $(t_{re})_{lim}$ , set at 38°C following EN ISO 9886. All three curves display the same three-stage profile where a short initial rise quickly gives way to a plateau where  $t_{re}$  flattens out, thanks to the evaporative cooling which is able to fend off the growing heat inflow. This second phase has a variable duration, inversely proportional to the heat load.

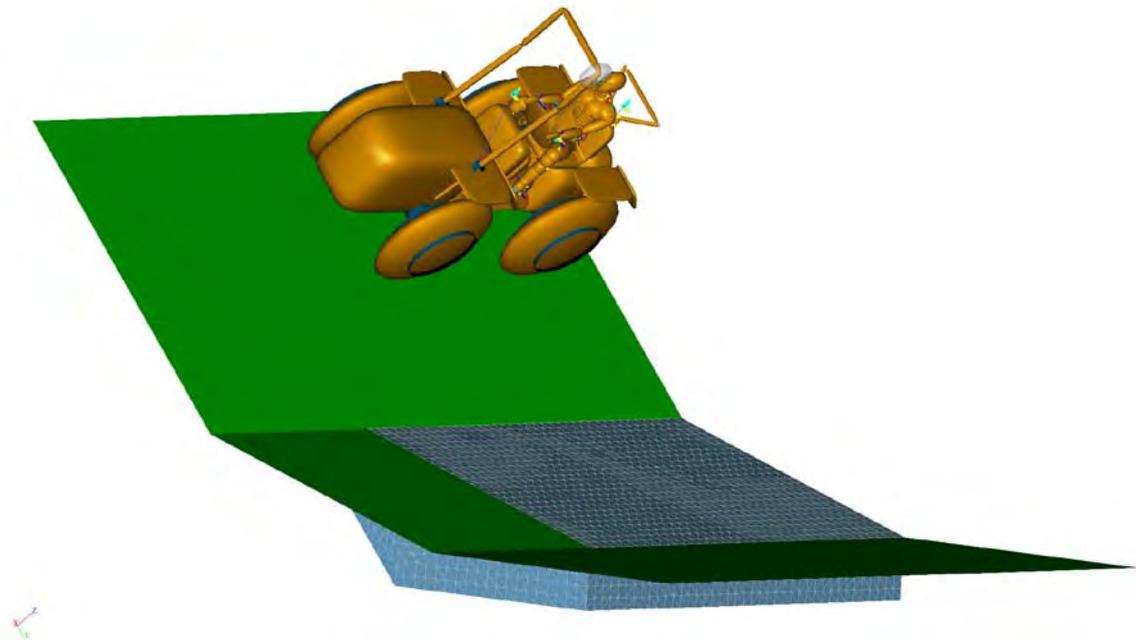
**Figure 1. 3D view of the accident scenario (the initial position of the simulations is represented)**

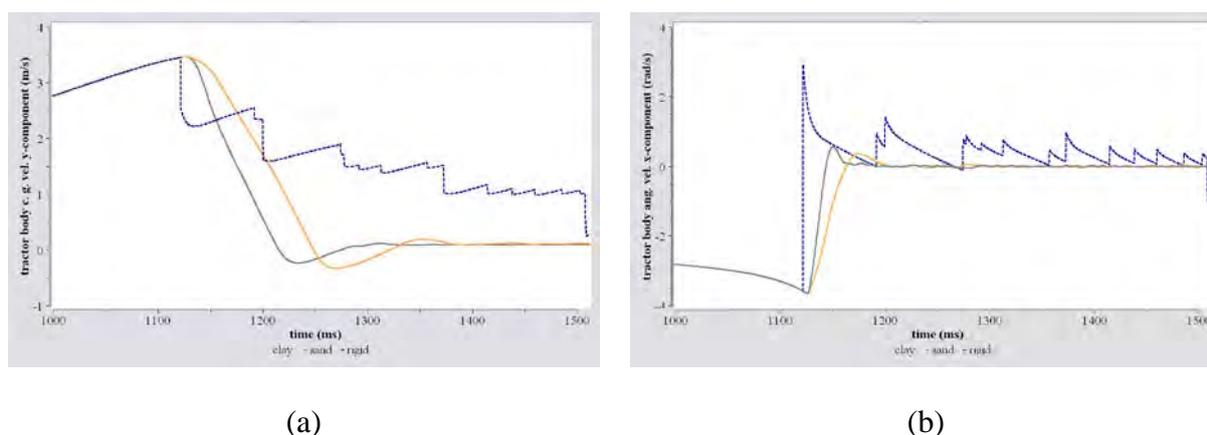
**Figure 3. The -component of the tractor body centre of gravity velocity (a) and the -component of the tractor body angular velocity (b) as functions of time**

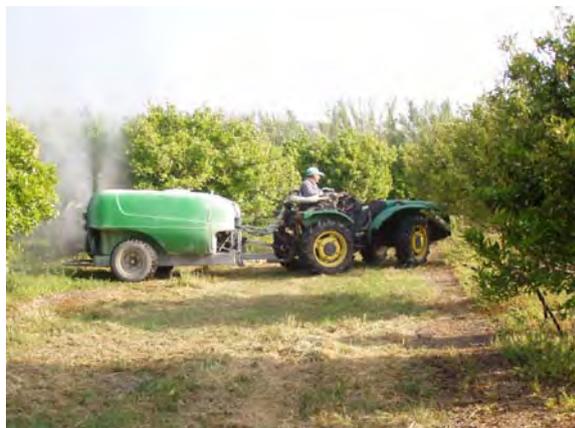
**Figure 1. Tractor and sprayer used.**

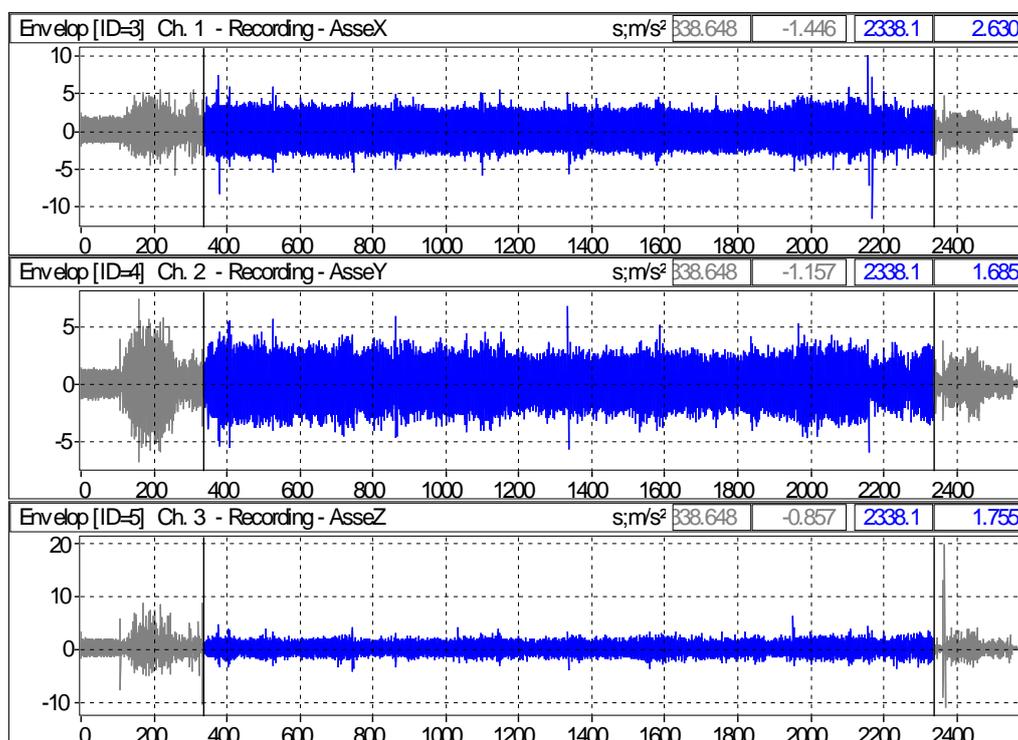
**Figure 5. Signal selection to analyse only the spraying activity.**

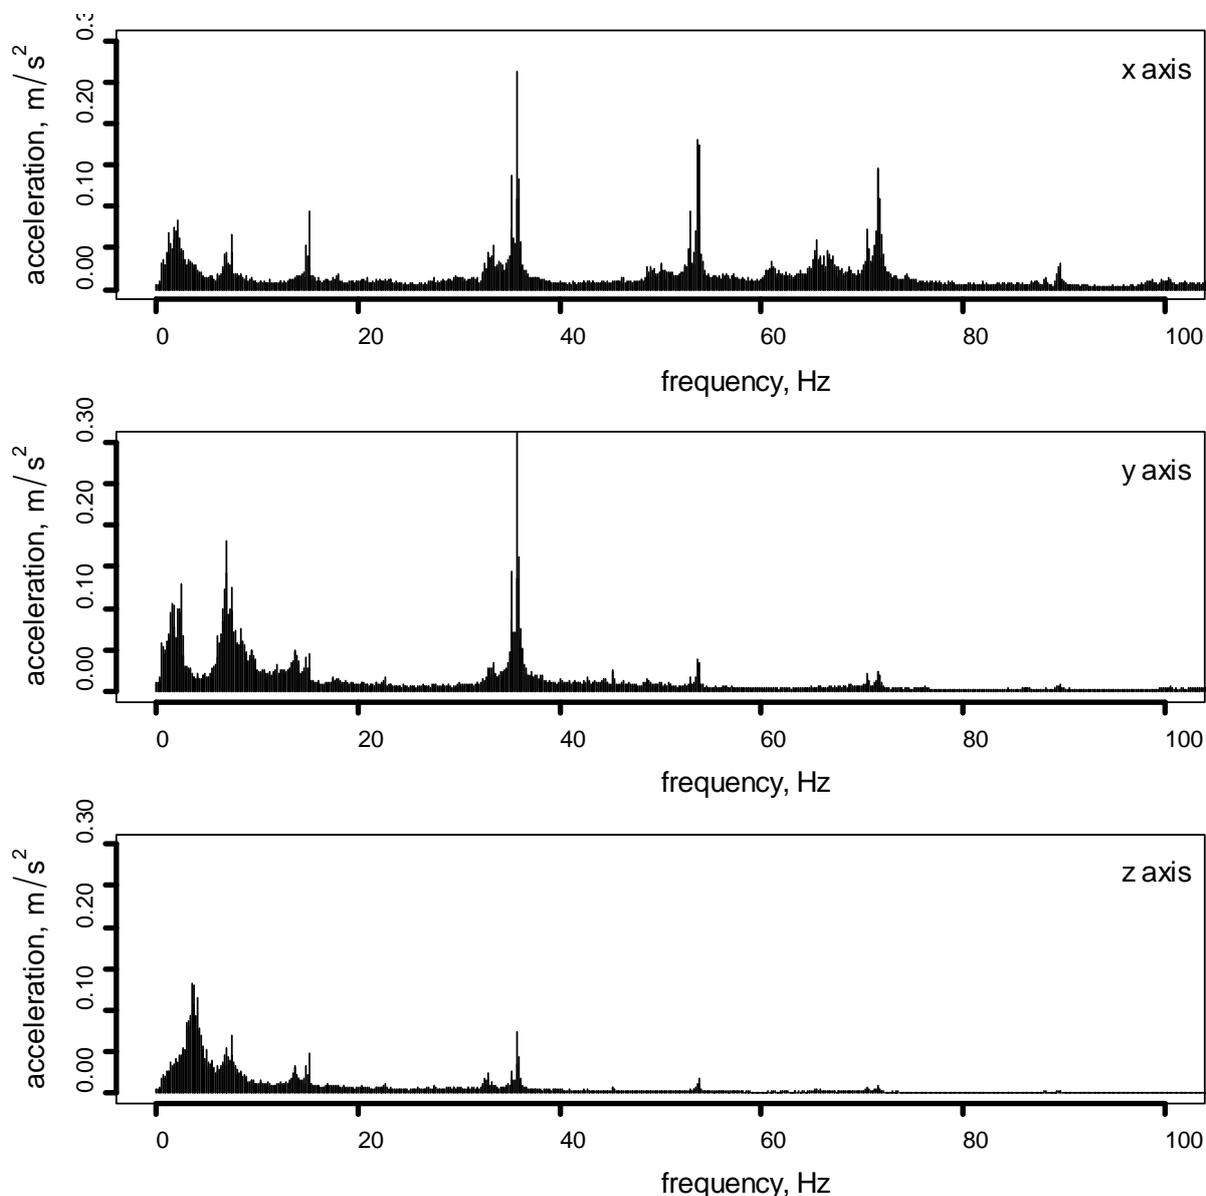
**Figure 7. Examples of FFT spectra.**

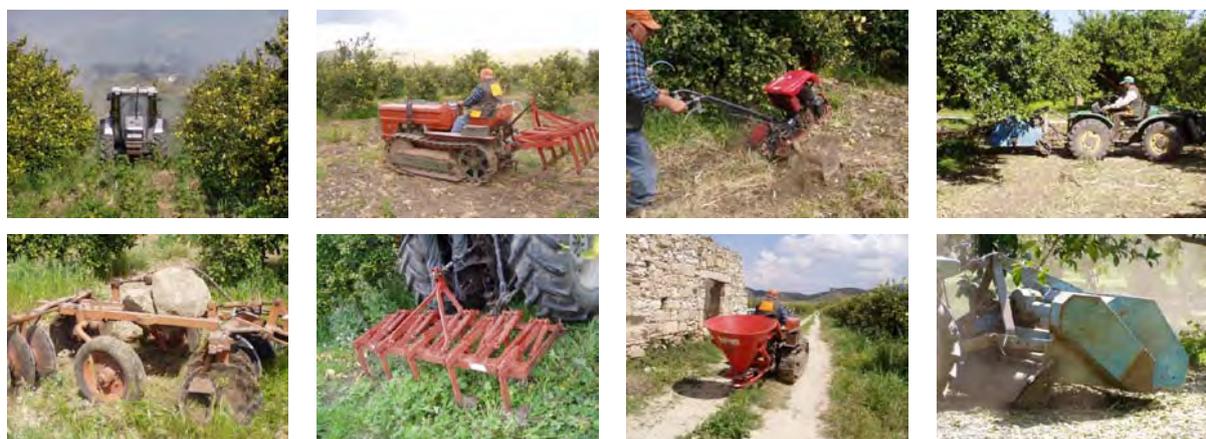
**Figure 1. Tractors and operating machines used for the experimental tests (from top to bottom, from left to right): wheeled tractor with cab; tracked tractor; rototiller; wheeled tractor without cab; disk harrow; tooth harrow; fertiliser; pruning triturator.**

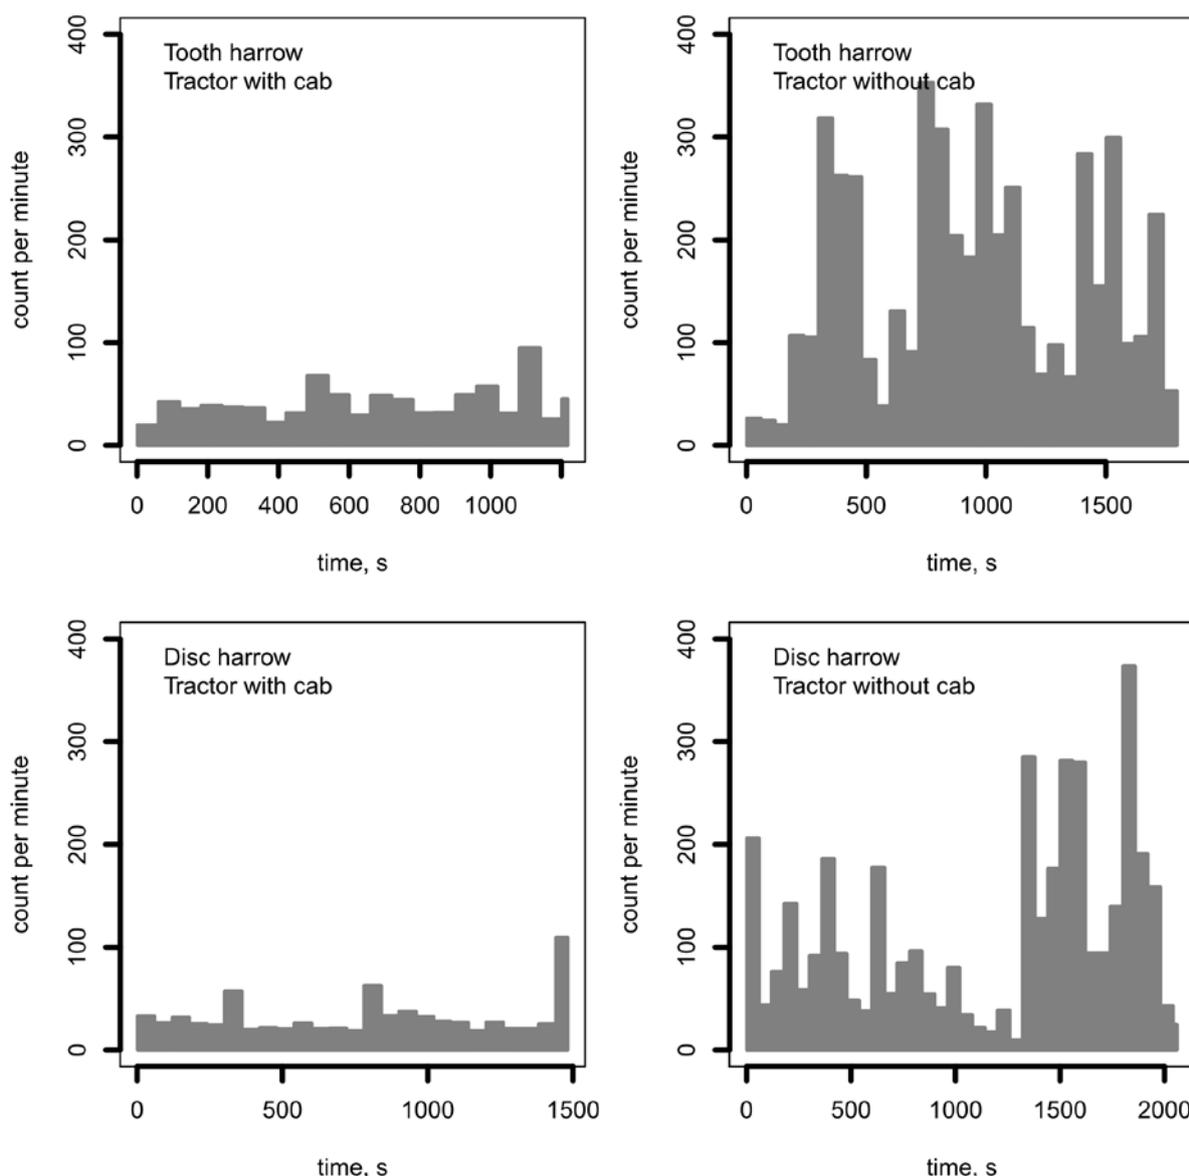
**Figure 4. Dust concentration (average values at every minute).**

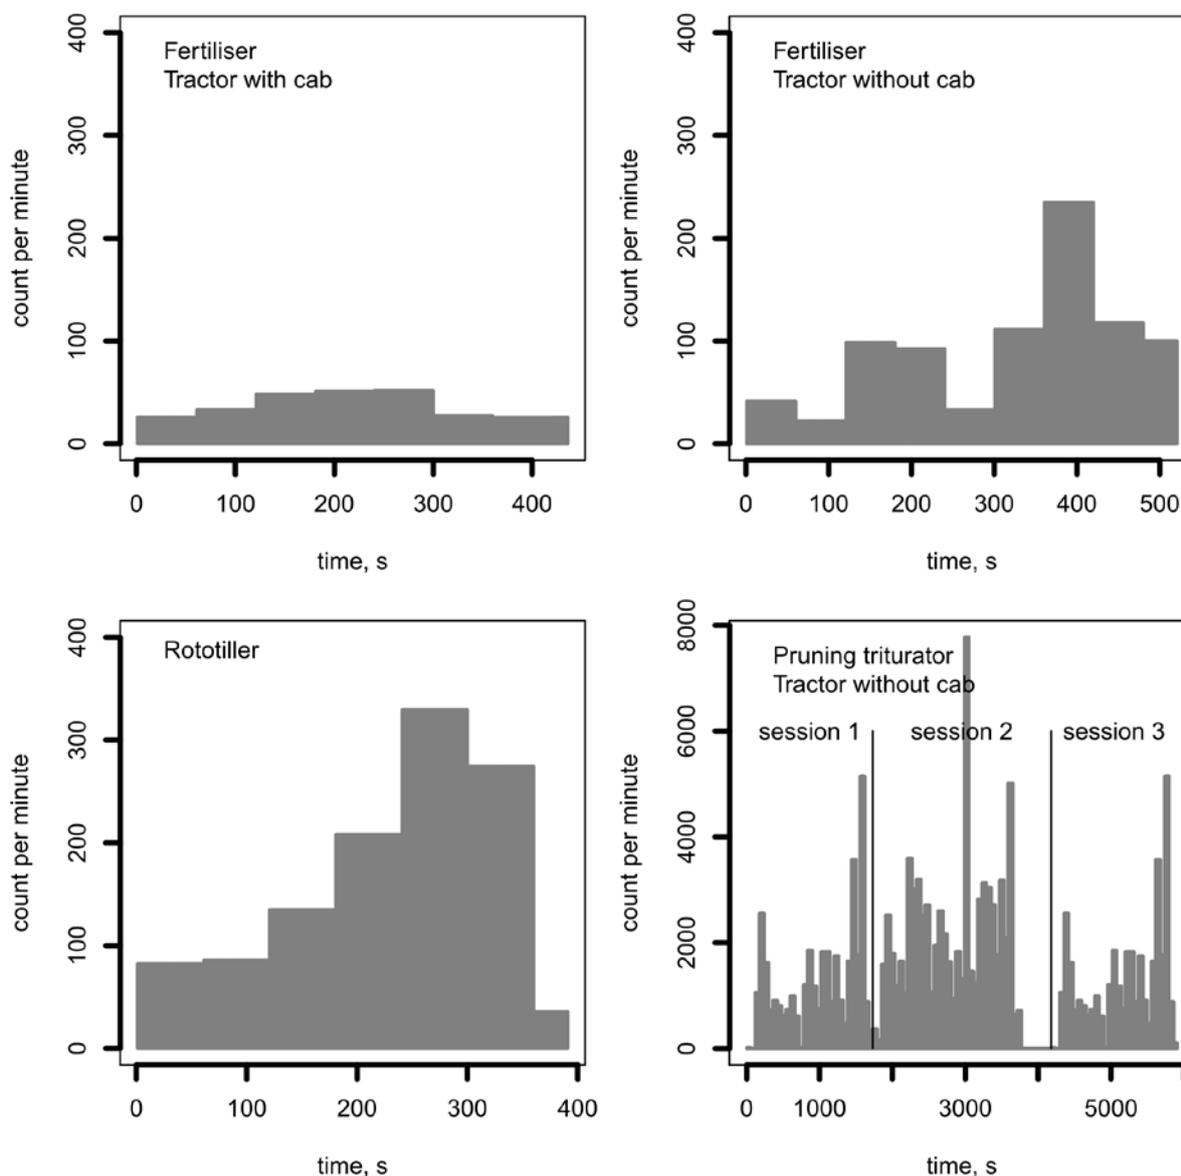
**Figure 5. Dust concentration (average values at every minute).**

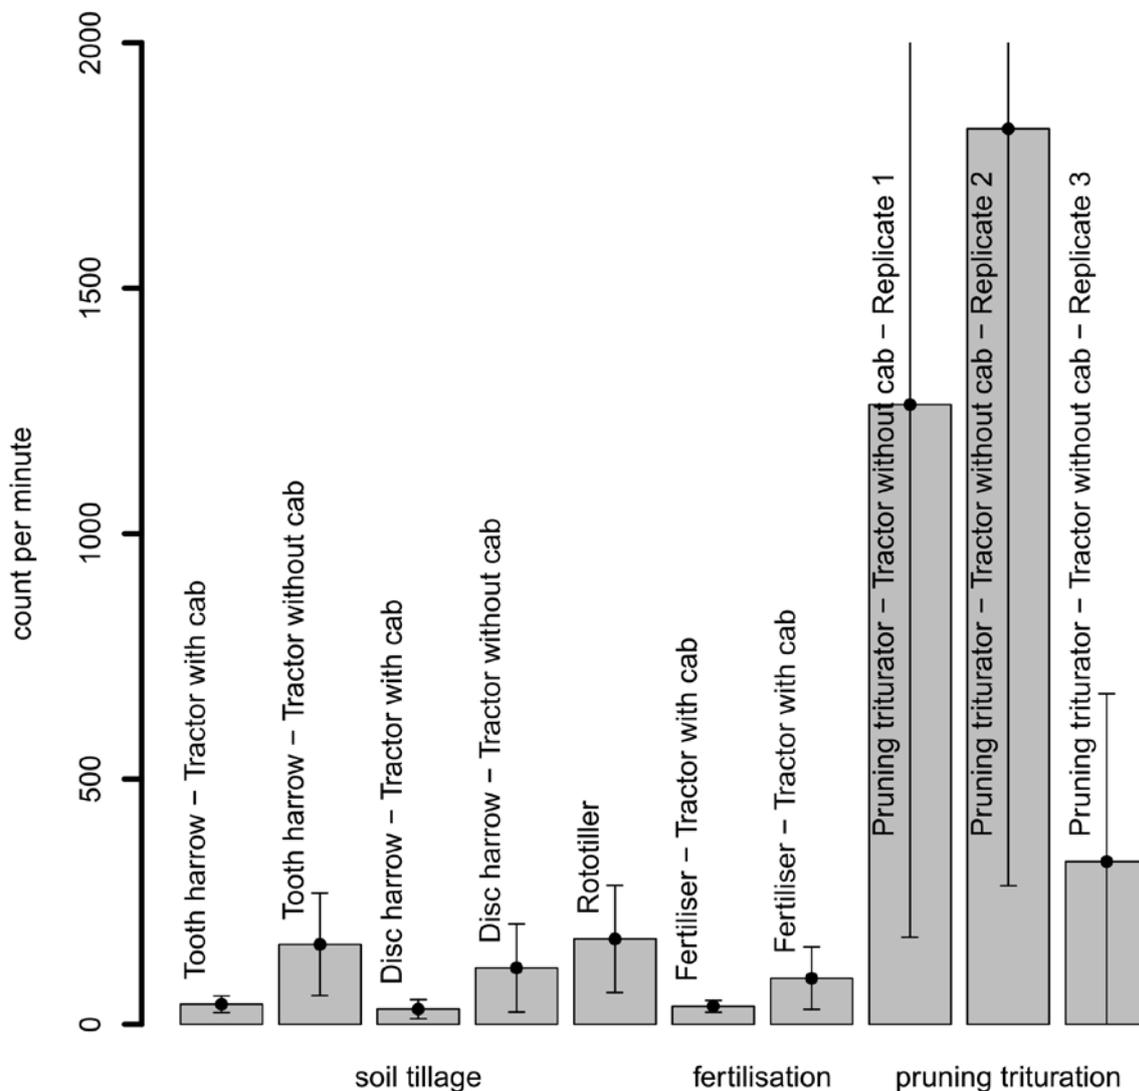
**Figure 6. Dust concentration (average values and standard deviations for each cultural operation).**

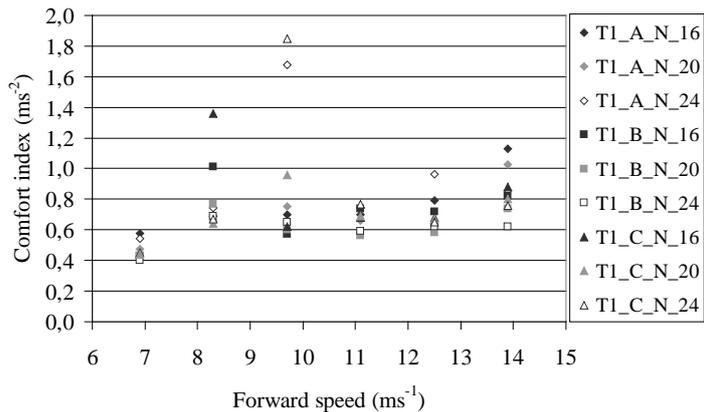
**Figure 1. CI values obtained in T1 with: different tyre marks (A, B, C); the tractor without ballast (N); the pressure of the tyres at 160 kPa (16), 200 kPa (20) and 240 kPa (24).**

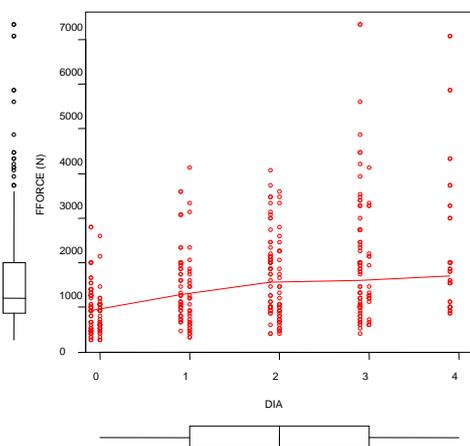
**Fig. 1: Distribution of forces in the observed diameters**

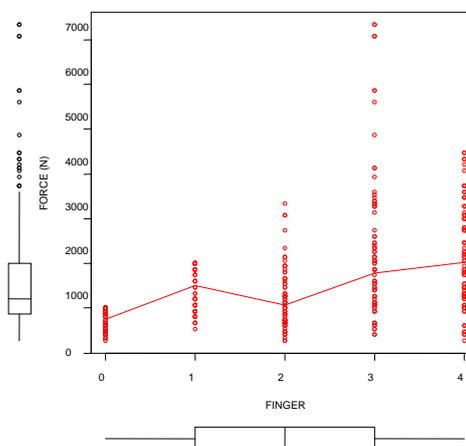
**Fig. 2: Distribution of forces in the observed regions of the hand**
